ETHILON, INC.

SEVEN YEAR DATA FOR TEN YEAR PROLENE™ STUDY: ERF 85-219

This report contains a summary of IR, IV, GPC, OM and SEM data supporting this study.

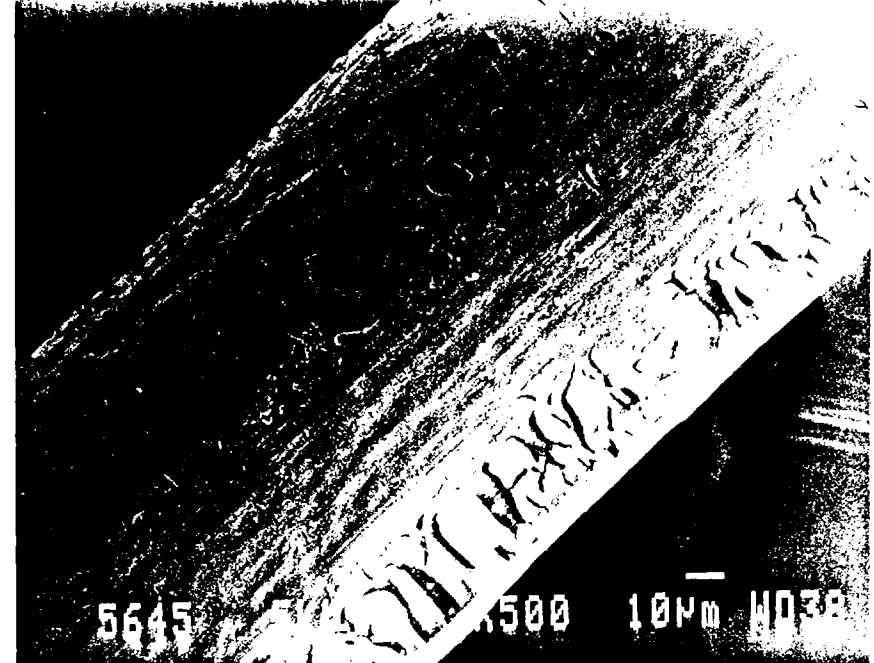
Figure 4 7 Year Ethilon Explants

In Figures 3 and 4 the cracking and abrasion on sutures from all six sites, as observed with the SEM, is shown. Here also the decrease in diameter is particularly dramatic in Figure 3 site 1.

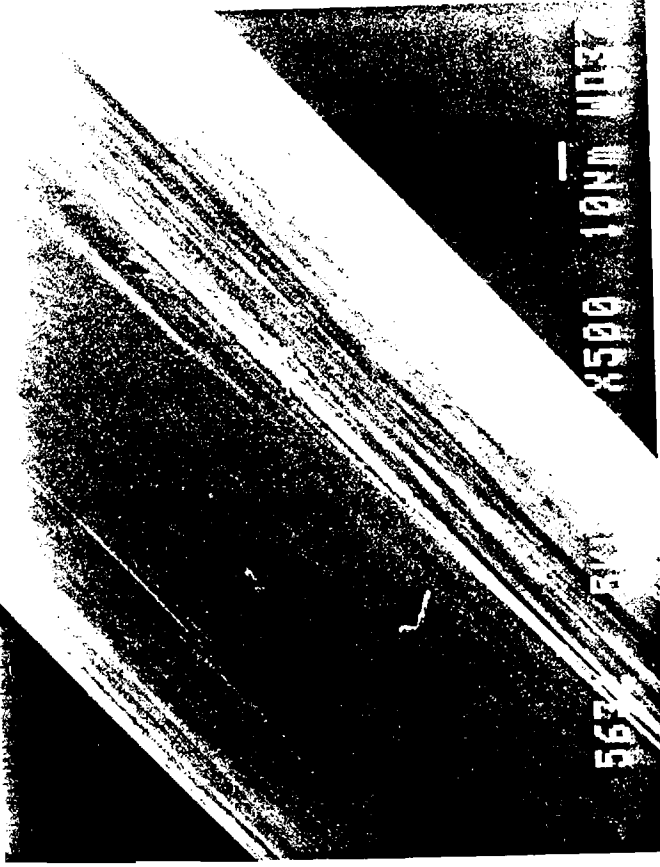
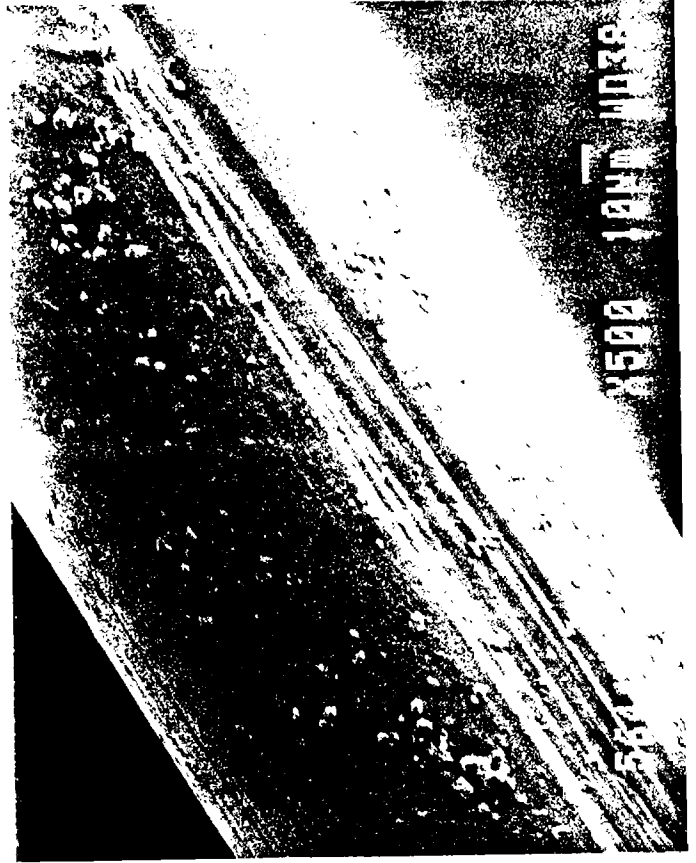
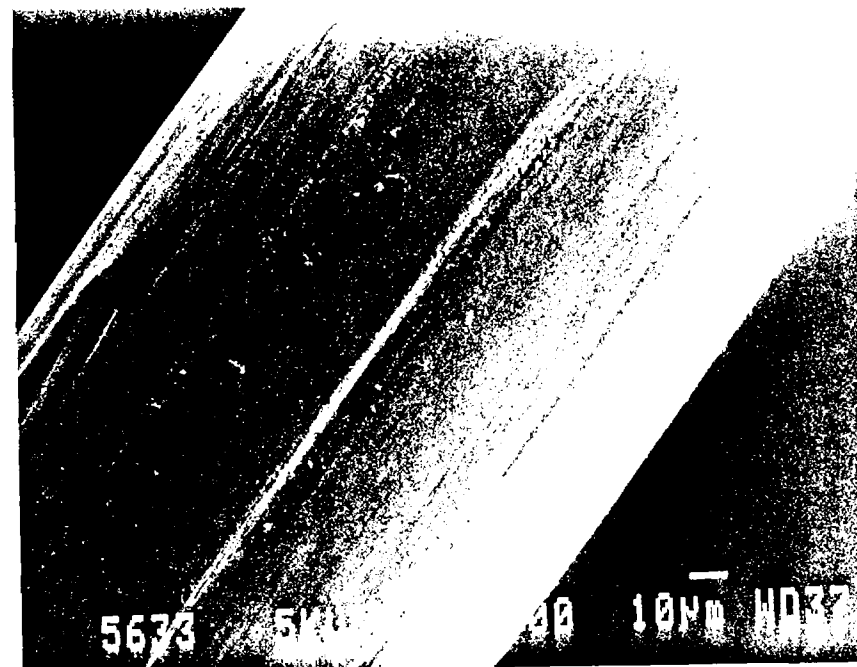
Figure 5 7 Year PVDF Explants

In Figures 5 and 6 the SEM examination of the PVDF sutures is shown. Only on the suture from one site (Figure 6 site 6) some cracks are found. The surfaces of the sutures from the other five sites show some striations which could be mechanical damage, otherwise the surfaces look intact. The contaminant on the site 4 (Figure 5) suture is tissue which had not been removed completely.
